# **BUILDING'S 40 YEARS OR OLDER ELECTRICAL CERTIFICATION REPORT**

**157 Sussex H  
West Palm Beach, FL 33147**

Re: 40/50-year Recertification.

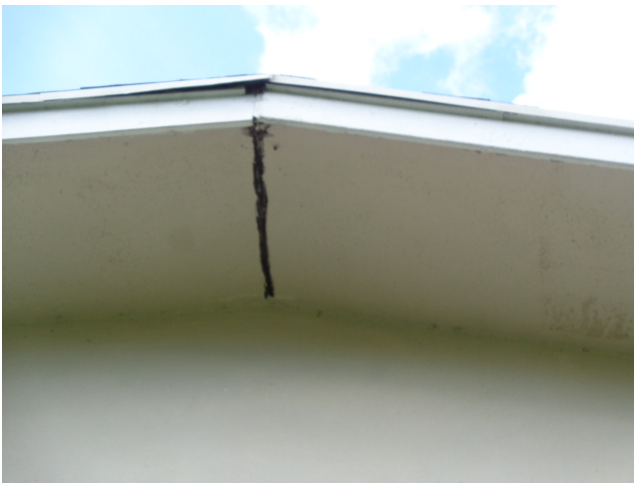
Also visible, were openings at the ridge fascia and soffit miter joints. These should be sealed up.

Figure 2..Open miter joints at ridge and fascia

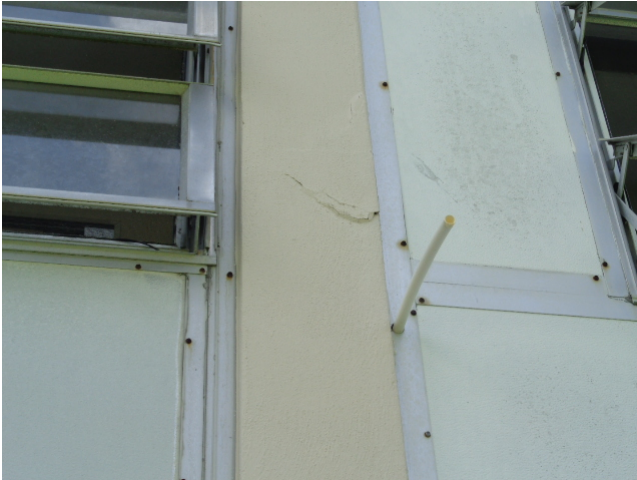
Figure 3...Column spalling # 159 Northside

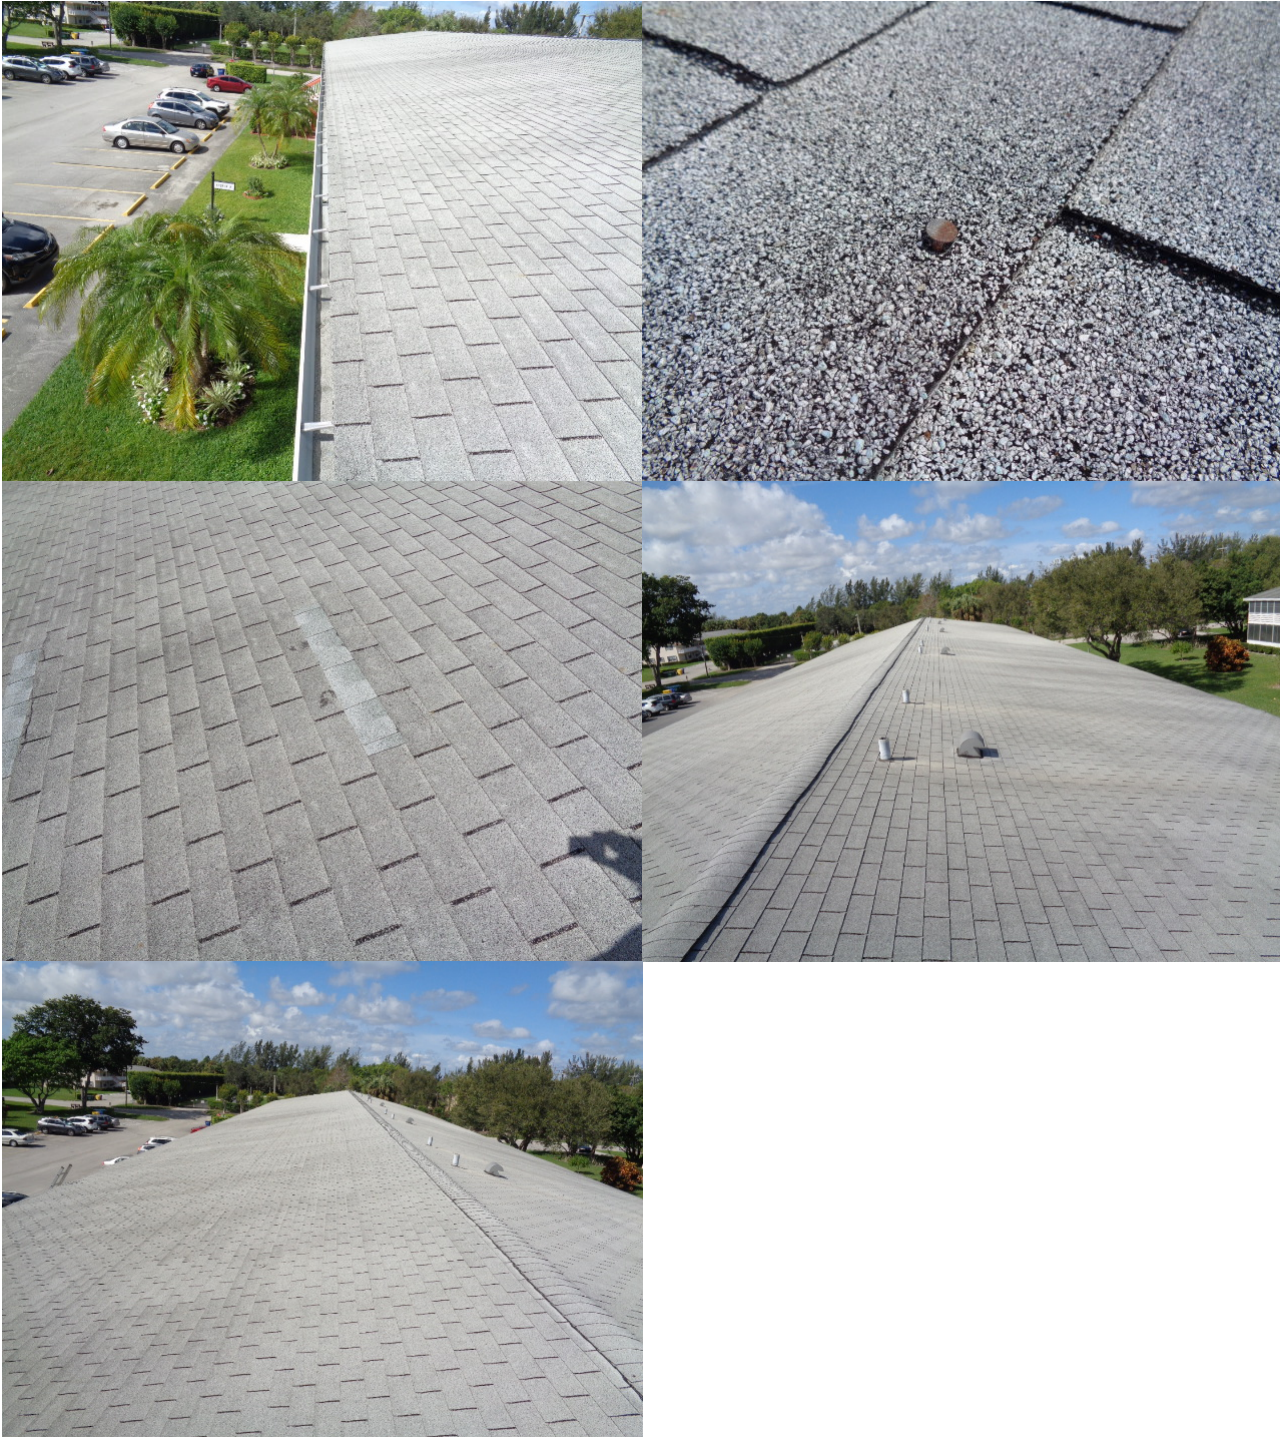
Some backed out nails were observed when inspection was performed.

Figure 6...ROOF Pictures show repairs and backed out nails

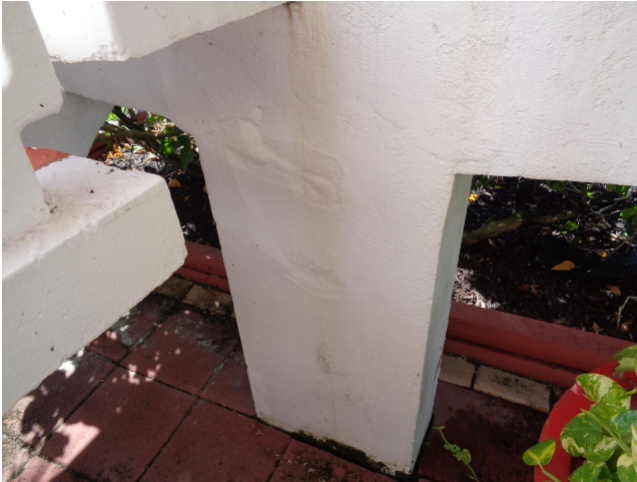
Figure 7...Column spalling at east stair

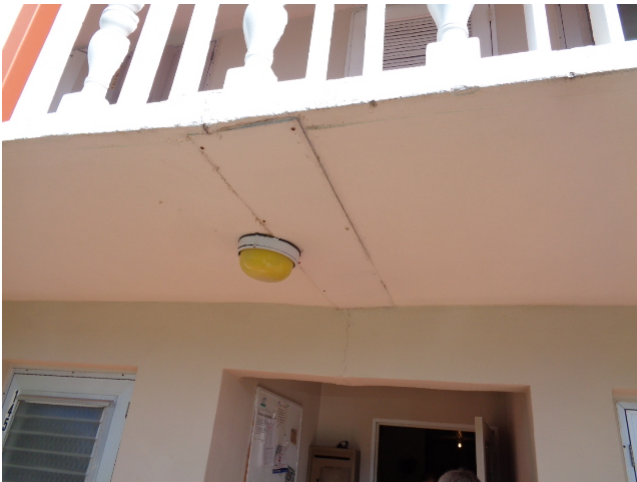
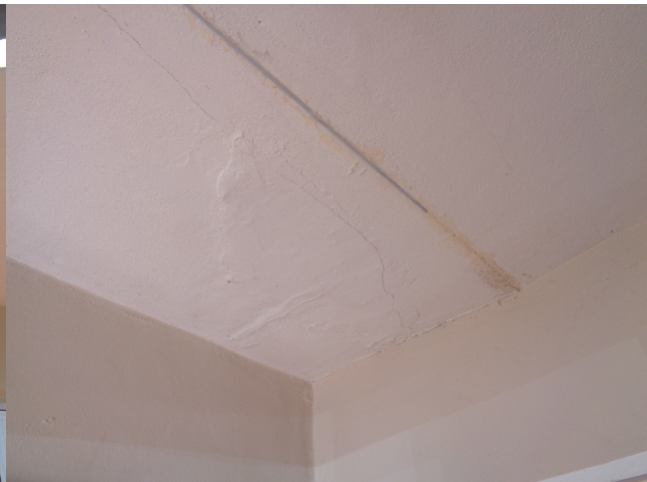
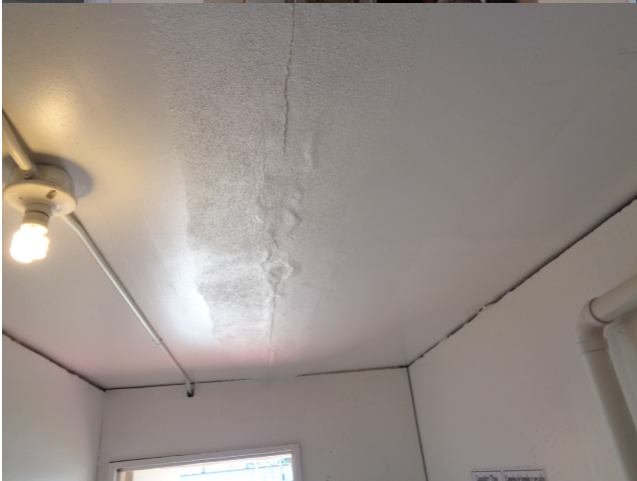
Note: The expansion joints in the catwalk show wear and should be re-done with a protective flat walk plate covering them. The joint by the laundry room is responsible for the soffit spalling at laundry room soffit.

Figure 8...Expansion joint at laundry room shows spalling in joint proximity

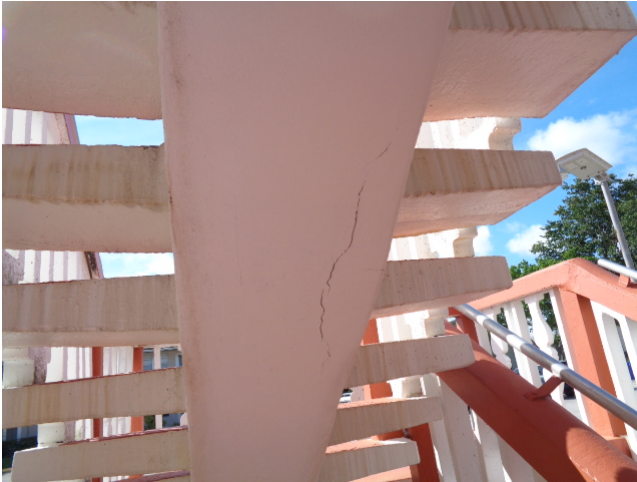
Figure 9...West stair beam spalling

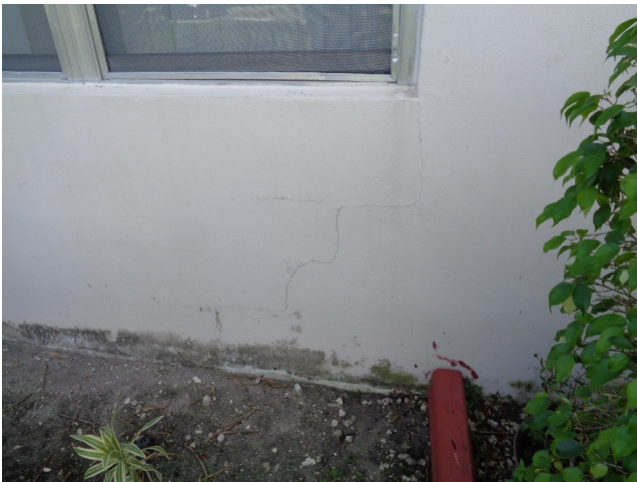
Figure 10...Stair case type cracking on wall west side.

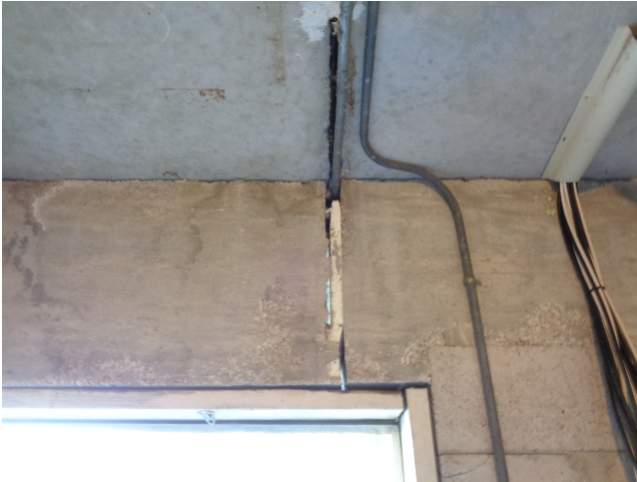
Figure 11...laundry room door should be sealed and finished, Also leaking expansion joint.

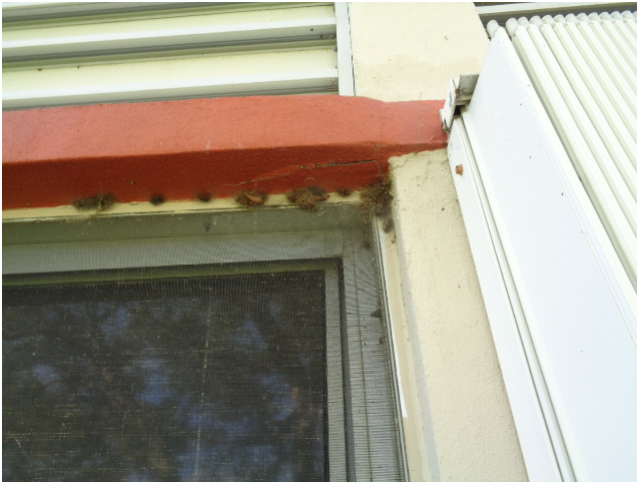
Figure 12...Edge spalling

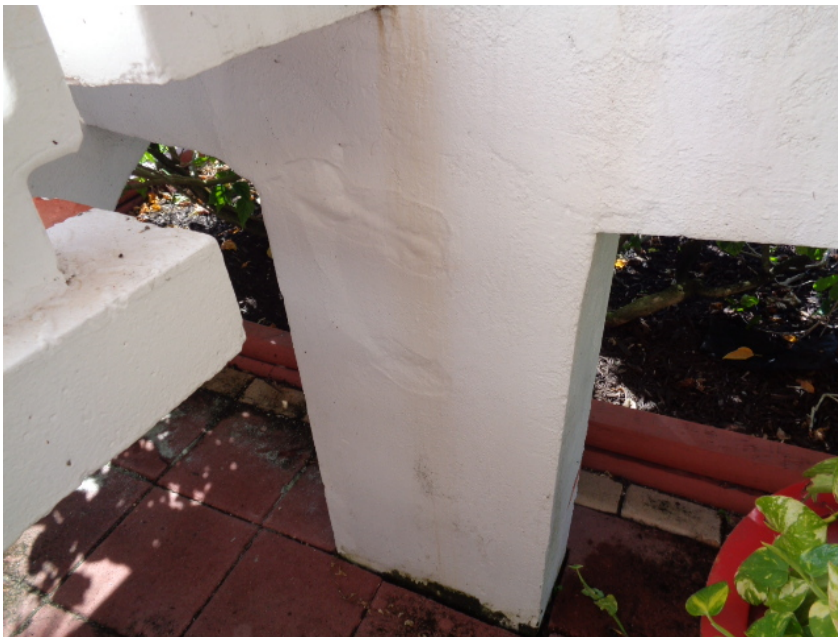
**NCI-2: Column spalling at SE stairways**

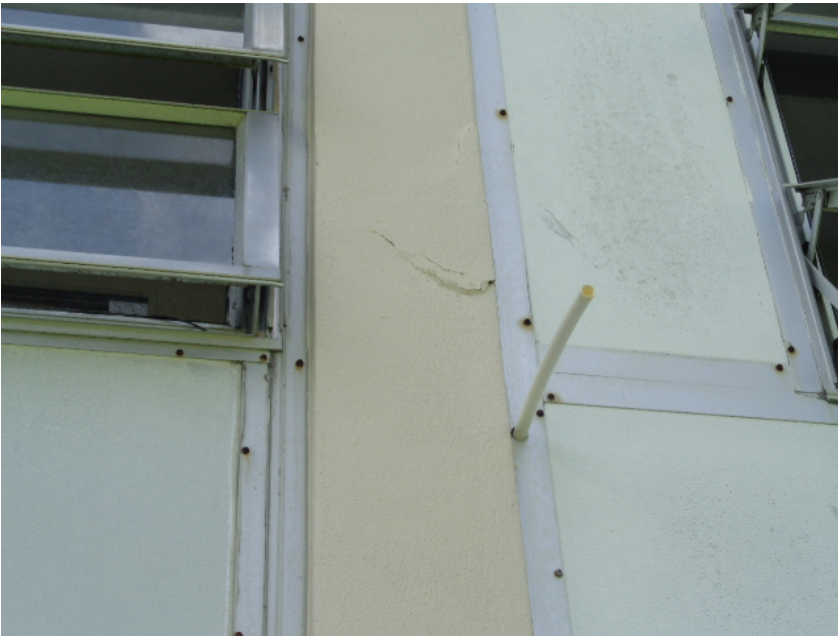
**NCI-3: Column spalling between unit 157 &158**

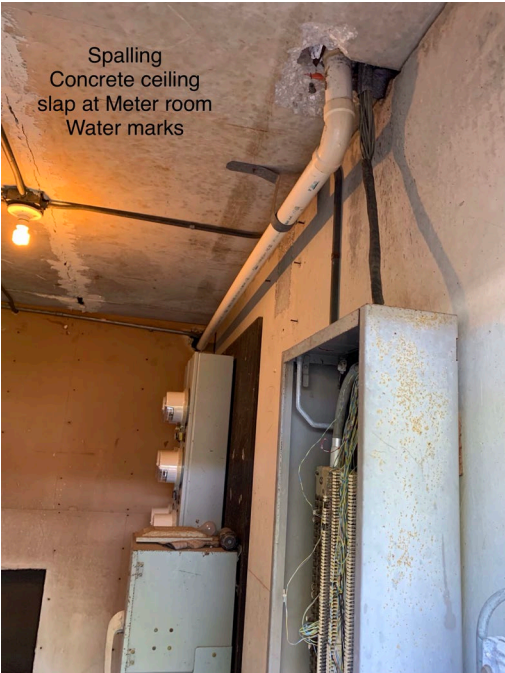
**NCI-4: Spalling in concrete ceiling slab Meter room**

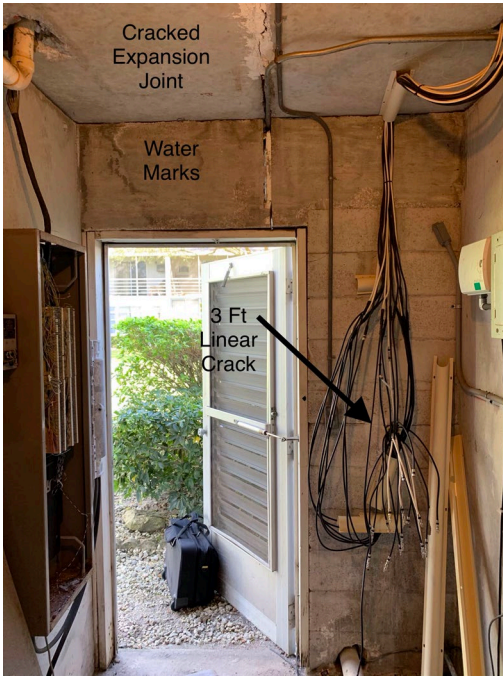
**NCI-5: 3 FT linear wide crack, misaligned door frame and water marks in meter room**

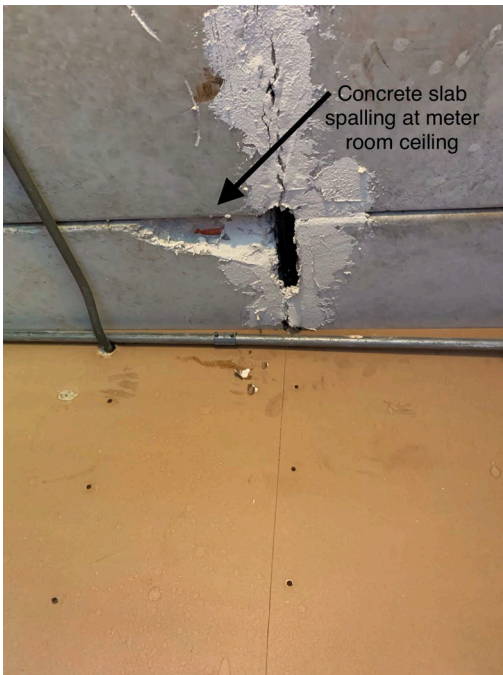
**NCI-6: Second spalling concrete ceiling slab in meter room**

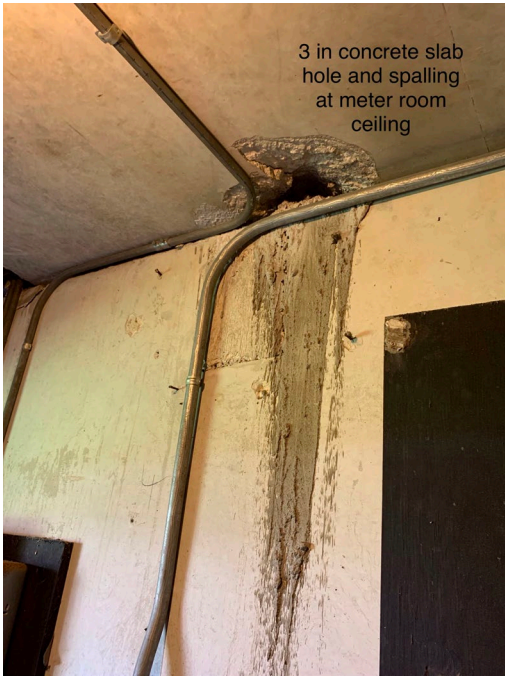
**NCI-7: Third spalling concrete ceiling slab in meter room**

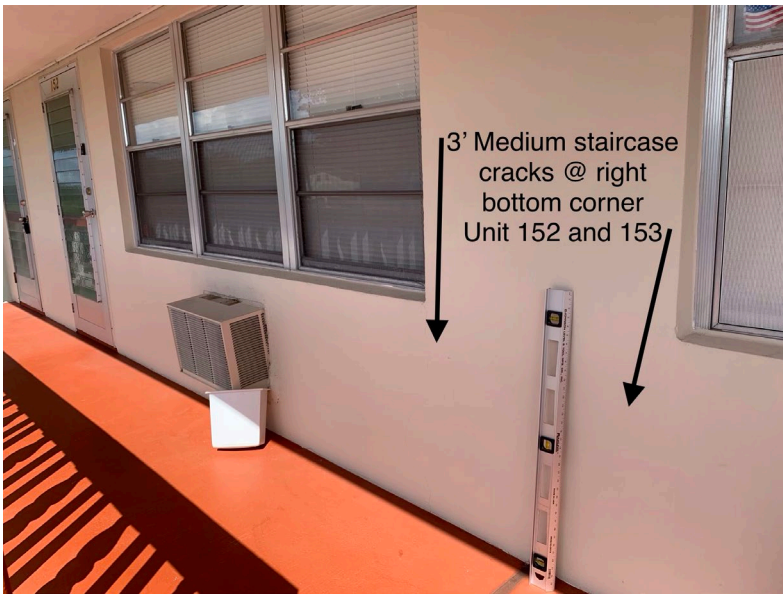
**NCI-8: (2) Two 3 Ft medium staircase bottom window corners**

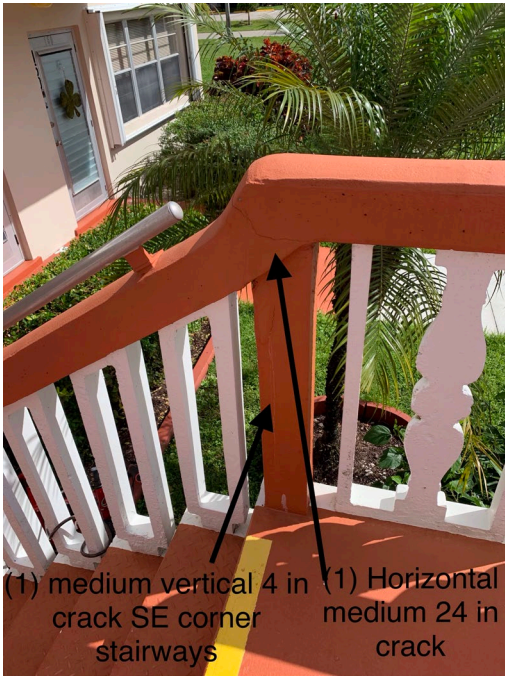
2. Description SE Stairways-Guardrail Post Cracks-1FT Horiz crack & 4" medium Vert crack (NCI-9)
3FT long medium cracks @ right bottom corner between unit 152 &153 (NCI-3)

(1) medium vertical 4 in crack SE corner stairways  
(1) Horizontal medium 24 in crack

**NCI-9: Cracked concrete SE stairway post**

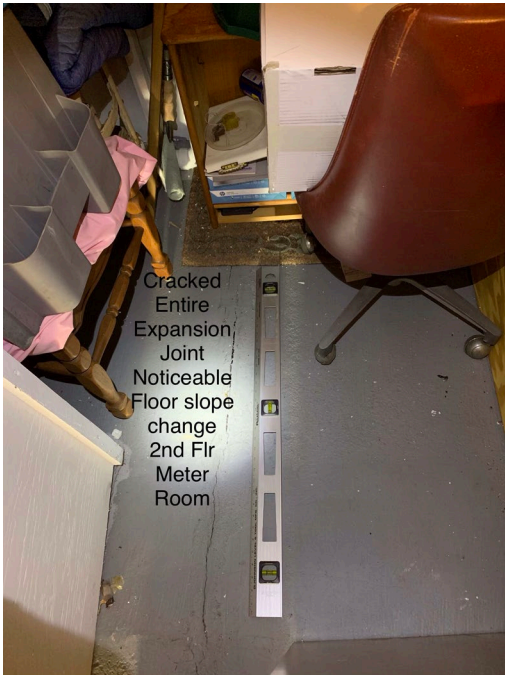
e. General extent of deterioration – cracking or spalling of concrete or masonry, oxidation of metals; rot or borer attack in wood.
Cracked Entire Expansion joint is to be repaired to preserve satisfactory building condition <b>(NCI-10)</b>
Aluminum frame sill along balconies are stained with water marks, Unit 145
f. Previous patching or repairs South Wall: (2) Two Evidences of 30 SF previous repairs, Window AC units
Previous repairs: Windows @ 2nd Floorb-East & West wall. 2nd Flr walkway slab-SW corner-Unit 151
Storage room Expansion Joint: Evidence of previous repairs and signs of moisture penetration.
g. Nature of present loading indicate residential, commercial, other estimate magnitude.
Multi-Family-Residential

Cracked Entire Expansion Joint Noticeable Floor slope change 2nd Flr Meter Room

**NCI-10: Cracked entire expansion joint and change of floor slope**

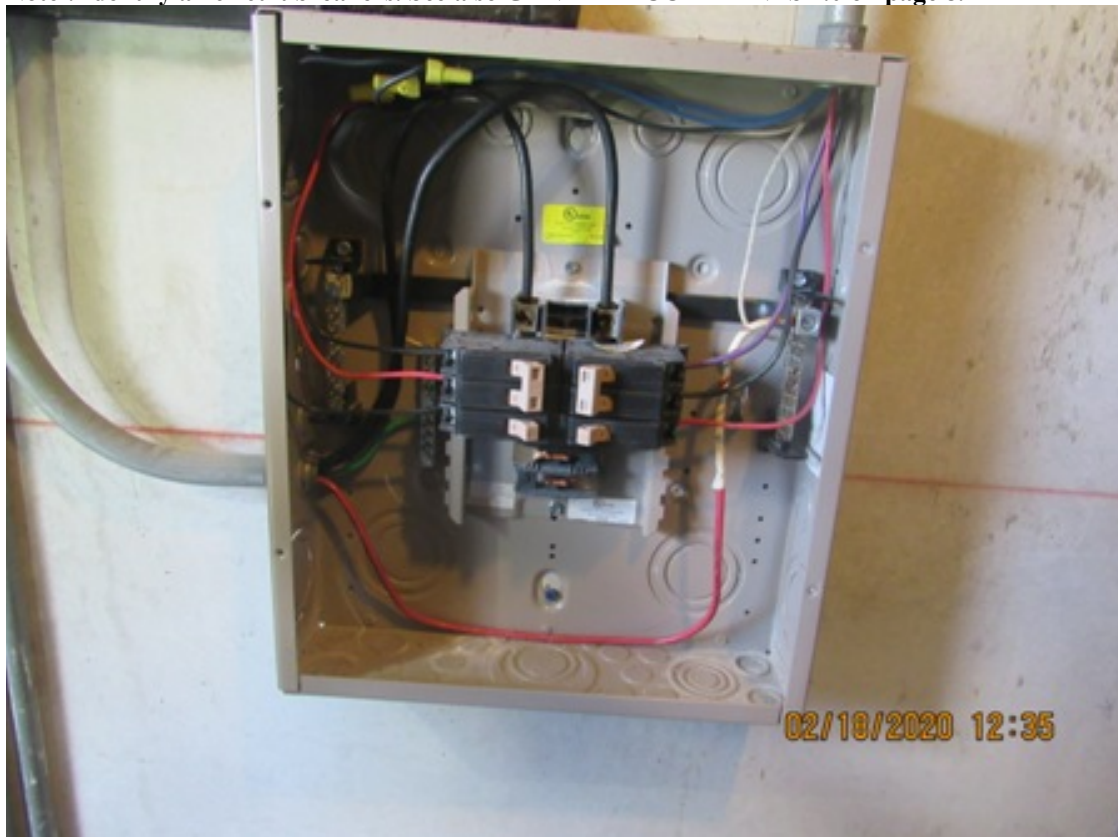
**Photo 4: Main electrical room- House panel II**

**Note: Size of feeder breaker/feeder wires couldn't be determined..**
