# **BUILDING'S 40 YEARS OR OLDER ELECTRICAL CERTIFICATION REPORT**

**157 Sussex H  
West Palm Beach, FL 33147**

Re: 40/50-year Recertification.

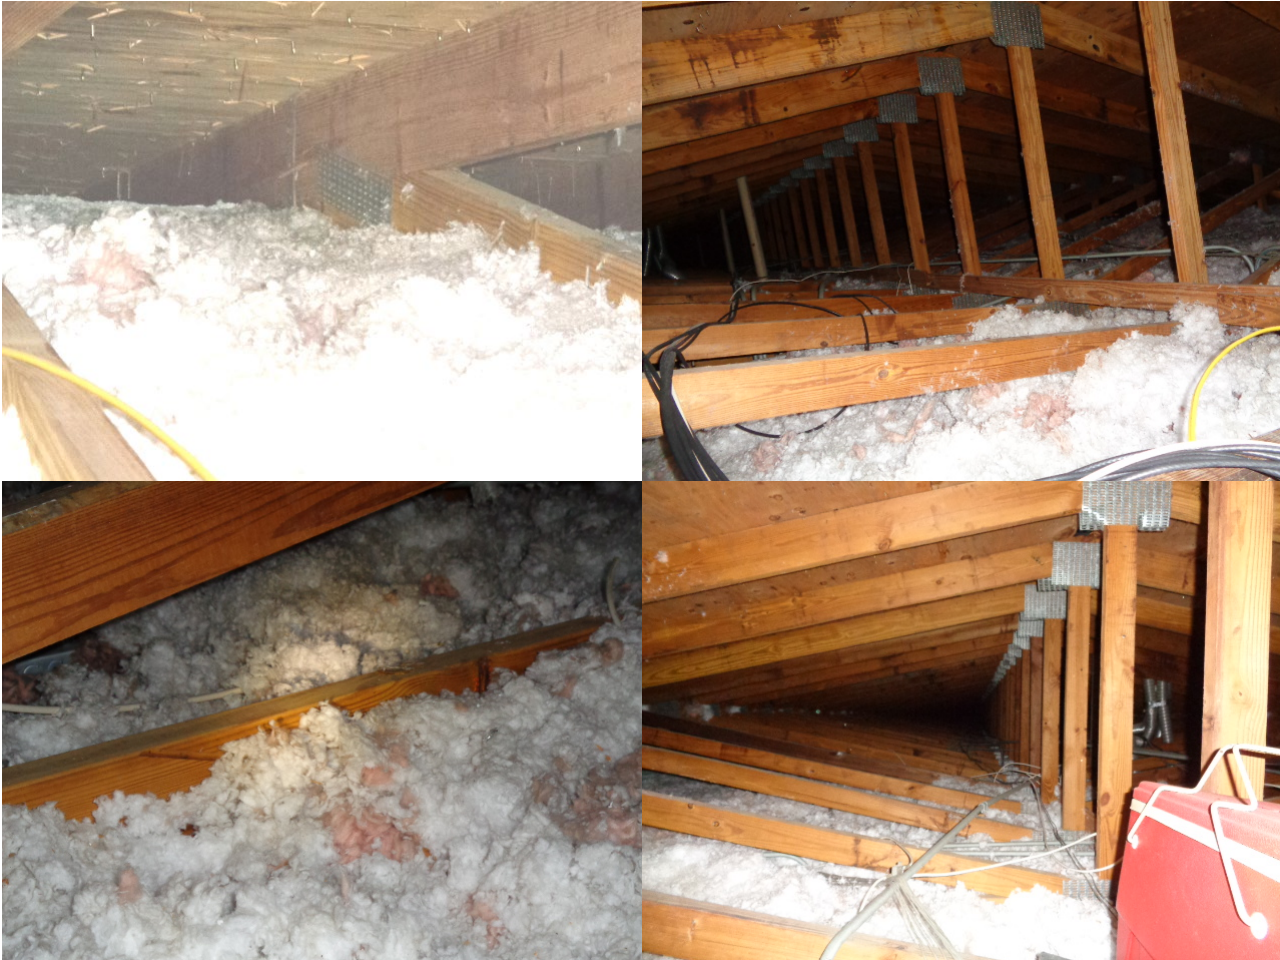
Figure 5...Attic

- The roof is engineered wood trusses. [2x6 top and bottom cords with 2x4 web supports]. The roof is 3-tab shingle covered and looks to be 8-10 years old.
- Some small repairs were visible from said hurricane damage.
- The attic area also was inspected showing no structural damage. Water stains from the previous roof was visible on trusses and plywood.
- Tie down straps were observed.
- This roof will pass a 40/50 year inspection. NOTE: no permit information was accessible. There were no complaints by tenants of any leaks reported.
